Townscape Improvement works at Bankhill

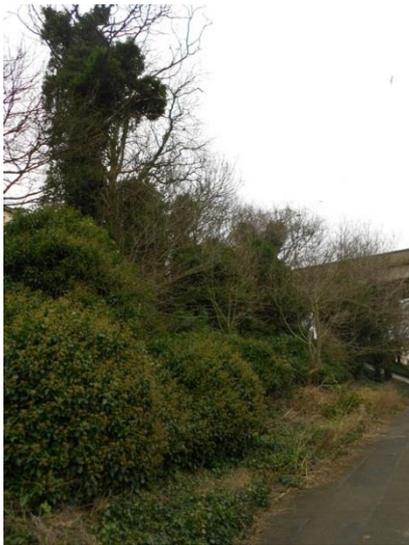
1. The area between Bankhill Road and the New Road has been an area left unmanaged for many years. The results of this are an increasing air of neglect both in terms of maintenance of physical infrastructure and management of vegetation, especially the areas immediately adjacent to the New Road itself [Photos 1 & 2].

Photo 1 Weed growth by New Road

11. In Phase 2, the focus will be on improving the appearance of the area adjacent to the New Road. This will involve clearing weeds and ivy from in front of the wall, levelling the ground, repairing and repointing the wall and planting the area with shrubs and perennials to complement the natural appearance of the bank behind and provide wildlife habitat in keeping with the rest of the New Road.

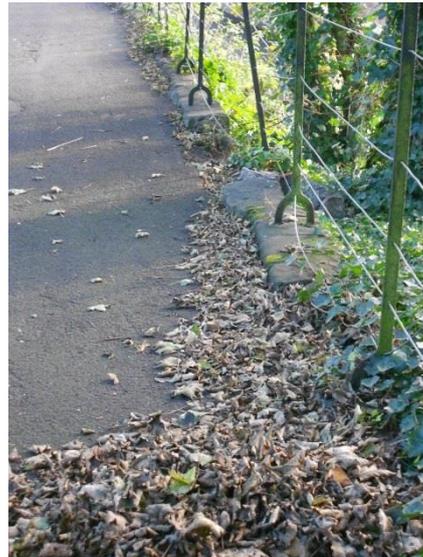
Photo 2 Fence condition, Bankhill

6. Work involved in Phase 1 focuses on Bankhill. In Phase 1, the post and wire fence will be repaired, along with the low stone wall at its base.
7. The work will involve replacement of damaged intermediate posts, installing new straining posts made to resemble the original, surviving cast iron ones and replacing and retensioning the fence wire.
8. The repairs to the stone wall will include replacing missing stonework and repointing the exposed wall below the fence.

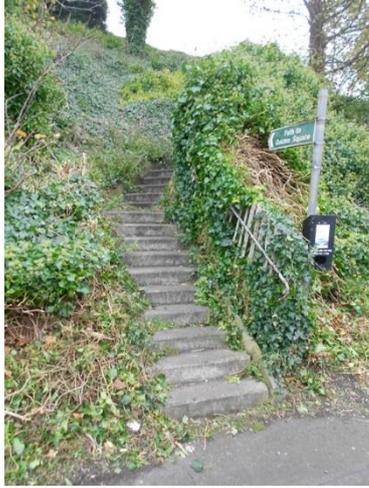
9. Additionally, Phase 1 will include a new replacement handrail for the steps between Bankhill and the New Road [Photo 3]. The current handrail is fashioned from scaffolding poles and is falling over in places. The replacement handrail will be in the same style as the handrails used throughout Castle Vale and Coronation Parks and the nearby steps leading up to Gillie's

Photo 3 Existing Handrail

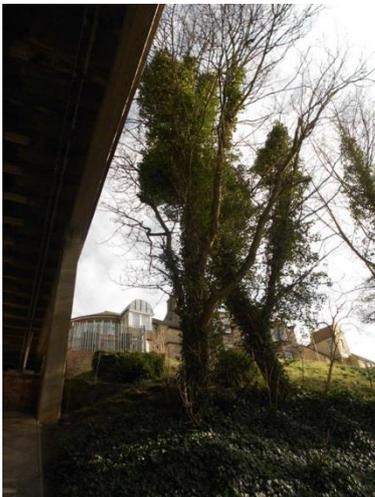
Photo 5 Tree too close to bridge

10. Finally, Phase 1 will see the removal of a small number of trees that are causing problems by growing too close to the Royal Tweed Bridge or on top of a wall at the foot of the bank [Photos 4 & 6].

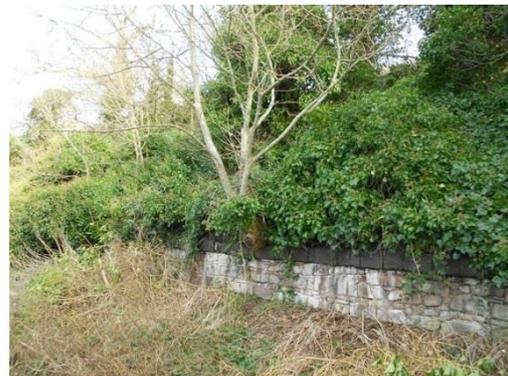
Photo 6 Tree growing on wall top
