**TYNE & WEAR PLAY LTD  
ANNUAL PLAYGROUND INSPECTION REPORT**

<b>Carried out for</b>	<b>BERWICK TOWN COUNCIL</b>
------------------------	-----------------------------

<b>Date of Inspection</b>	19/10/2021	<b>Time</b>	11:45	<b>Date of Report</b>	21/10/2021
---------------------------	------------	-------------	-------	-----------------------	------------

**SITE: SPITTAL PAVILION PLAY AREA, SOUTH GREENWICH ROAD,  
SPITTAL, BERWICK UPON TWEED. TD15 1RW.**

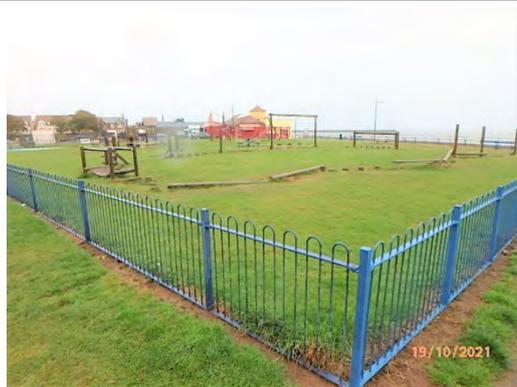
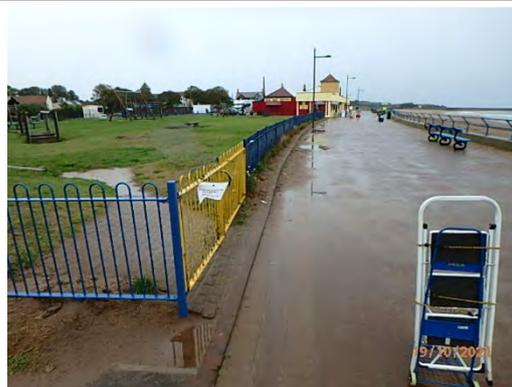
### SPITTAL PAVILION PLAY AREA

**Brief Description of Site and Location Context:** Medium sized fenced play area located on field next to sea front promenade at Spittal. Overlooked by houses on one side

General Site Checklist	Comment	
Traffic & Noise pollution	Low	
External Paths	Present – paths / promenade	
Internal Paths / Stable Access	Present – hoggin paths	
Fencing	85 cm bowtop	
Lighting	None	
Pedestrian Gates	3	
Maintenance Gates	1	
Operator Signs	3	
Seating	6	
Litter Bins	3	
General Surface	Grass	
Condition of Site	Fair	
Informal Surveillance	Overlooked from promenade and backs of houses	
House Proximity	15 m	
Vandalism	Low	
Accessibility - Into Site	Good	
Accessibility - To & between Equipment	Partial

<b>Advised Remedial Action</b>	Provision of hard stable access to and between equipment is needed to meet DDA requirements
--------------------------------	---

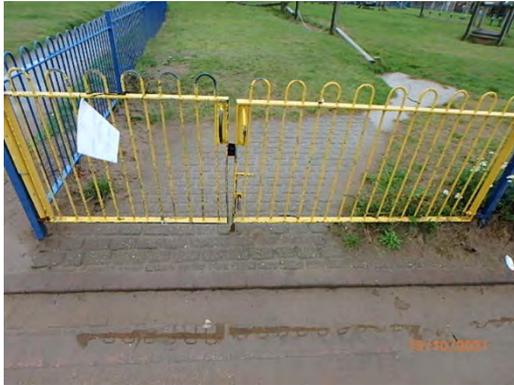
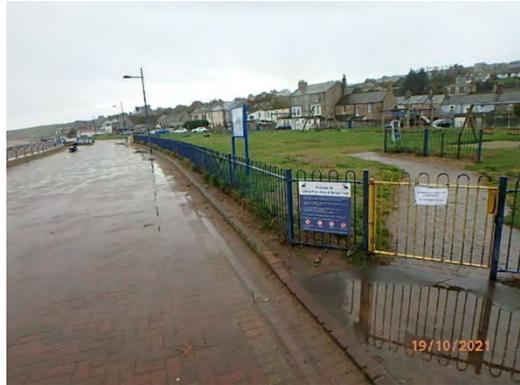
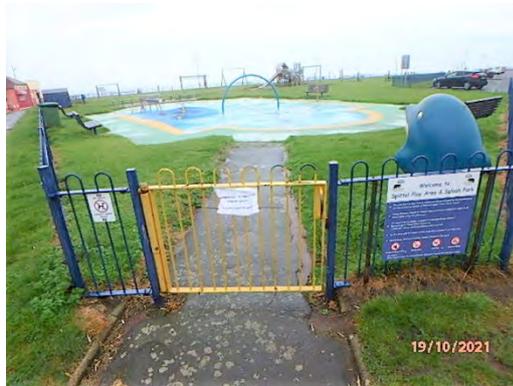
<b>A1</b>	<b>Gates</b>
-----------	--------------

(Splash Park entrance.)

<b>Finding A1/1</b>	<b>Type</b>	Maintenance
<b>Fault / Comment</b>	Crush / slam hazards present on gates due to missing stoppers.

Missing stoppers on gate slam plates

Crush / slam hazards

Missing keep plate on gate

<b>Risk Assessment</b>	Low	P	2	X	S	2	=	4
<b>Advised Remedial Action</b>	Replace missing or damaged rubber stops.							
	●

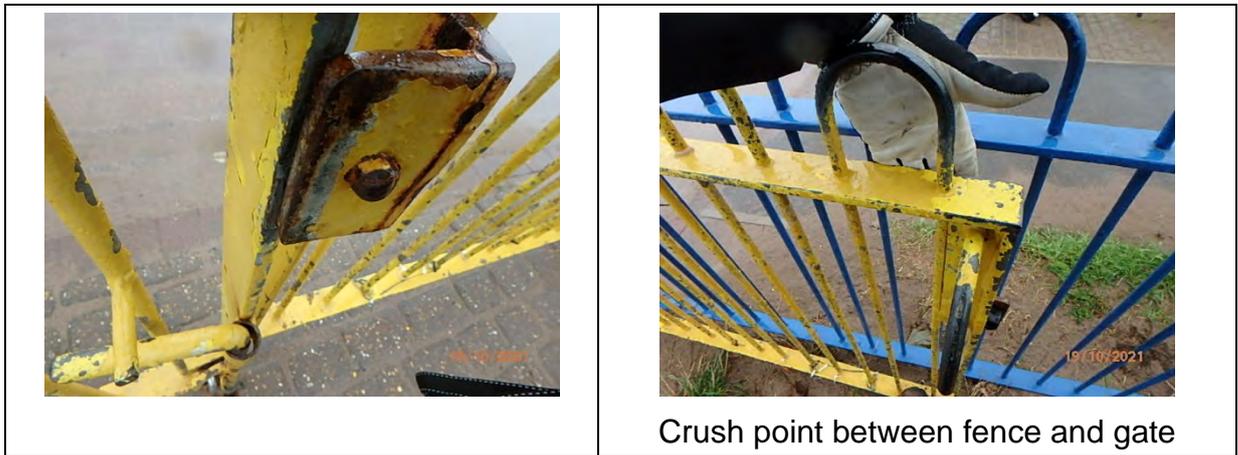
Crush point between fence and gate

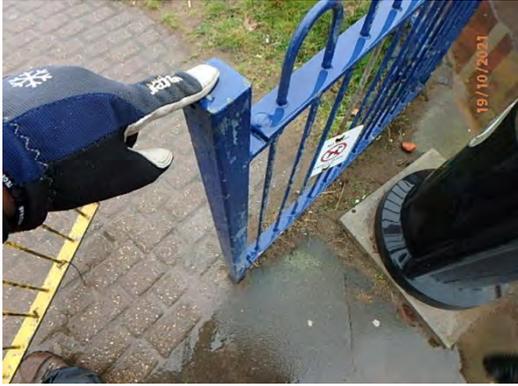
<b>Finding A1/2</b>	<b>Type</b>	Maintenance Issue
<b>Fault / Comment</b>	The item, component or parts described are not securely fixed, maintained or correctly installed and are loose or unstable -

<p>Gate post loose in ground</p>	
<b>Risk Assessment</b>	<p>Low P 2 X S 2 = 4</p>
<b>Advised Remedial Action</b>	<p>Re-fix loose post securely into ground.</p> <p style="text-align: center;">●</p>

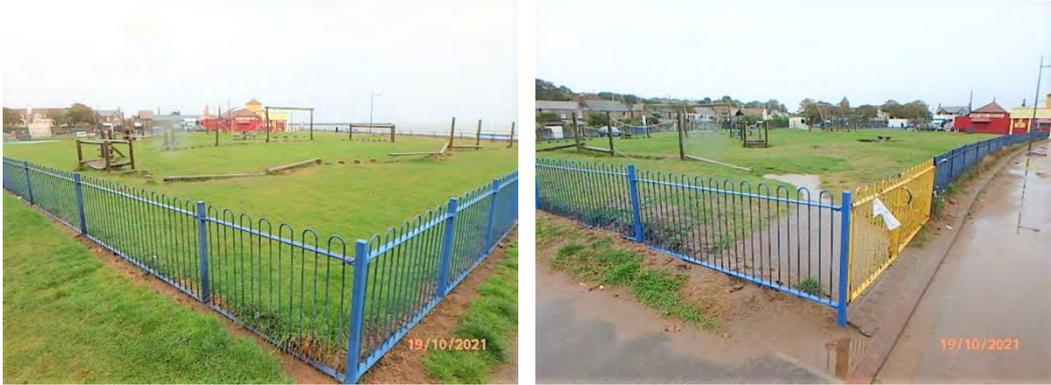
<b>A2</b>	<b>Fencing</b>

<b>Finding A2/1</b>	<b>Type</b>	Standard Compliance: BS EN1176
<b>Fault / Comment</b>	Head and Neck traps present above a height of 600 mm (Ref BS-EN1176 -1 / 4.2.7.2)

<p>Gaps between bow top bars fails the head and neck probe test</p>		
<b>Hazard</b>	Head and neck entrapment

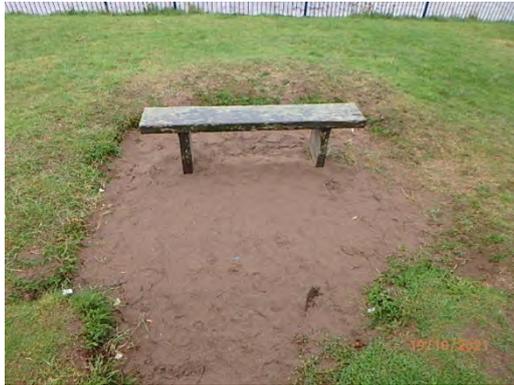
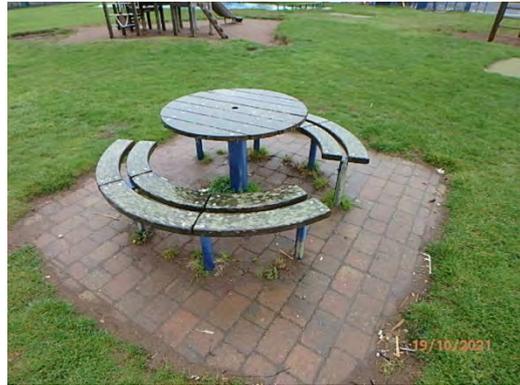
<b>A4</b>	<b>Seating</b>

<b>Finding A4/1</b>	<b>Type</b>	Maintenance Issue
<b>Fault / Comment</b>	Weeds, moss, algae, tree sap, leaves etc. present on surface / equipment

<b>Hazard</b>	Slips
<b>Risk Assessment</b>	Low P 2 X S 2 = 4
<b>Advised Remedial Action</b>	De-weed and thoroughly clean the surfaces. Power-wash to remove algae, moss, tree sap etc. ●

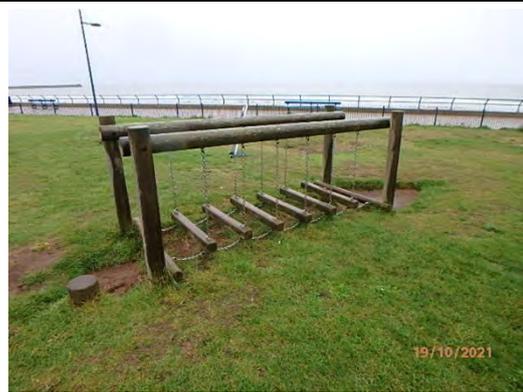
Clatter Bridge

<b>Manufacturer</b>	Playdale
<b>Manufacturer’s Label Present?</b>	Yes
<b>Year of Supply</b>	2004 – indicative end of operating life 2019*
<b>Accessibility (DDA)</b>	Limited
<b>Surface</b>	Grass and sand
<b>Standard Compliance (EN 1176)</b>	See below
<b>Maintenance Issues / faults</b>	See below

There exists a continual risk of rotting or corrosion of the posts below the playing surface and also possibly in the foundations where the posts are embedded.

These posts are subject to dynamic loading, (loading stress caused by movement,) and their structural strength will be significantly impaired by rotting or corrosion which, in the worst case, can lead to a catastrophic cross- section failure of the timber.

Various manual checks carried out in this inspection of the posts above the ground (side-loading, percussion- testing and spot- probing) **have indicated some issues of instability, loosening** and/or degradation of the posts (rotting or corrosion.)

Finding 01/2	Type	Maintenance
<b>Fault / Comment</b>	Post loose in ground when side loading applied. This may indicate rotting of posts below ground level.  <u>Note: condition of the timber was not checked below the surface level. Further checks required of posts under the surface and at foundation level.</u>

<p data-bbox="895 1599 1401 1704">Condition of timber below ground is unknown. Possible rot and/or loose foundations</p>	
<b>Hazard</b>	These single post items are subject to dynamic loading (loading stress caused by movement,) and their strength and stability will be significantly impaired by rotting / corrosion. There is a particular risk of rotting or corrosion of posts below the playing surface and in the foundations where the posts are embedded in concrete.	
<b>Advised Remedial Action</b>	In view of the age of this adventure trail, <u>all single posts in the trail should be replaced</u>

**All these single posts should be replaced**

<ul style="list-style-type: none"> <li>• Manufacturer's Label on the play equipment shows that the equipment was installed in 2004. The equipment is therefore 17 years old and planning should begin for its decommissioning / replacement..</li> <li>• <b><u>All single posts in the trail should be replaced.</u></b> (see 01/1 and 01/2 above.)</li> <li>• Going forward, the equipment should be regularly checked and repairs carried out as required to ensure condition of equipment does not deteriorate until such time as the equipment can be replaced / removed.</li> </ul>

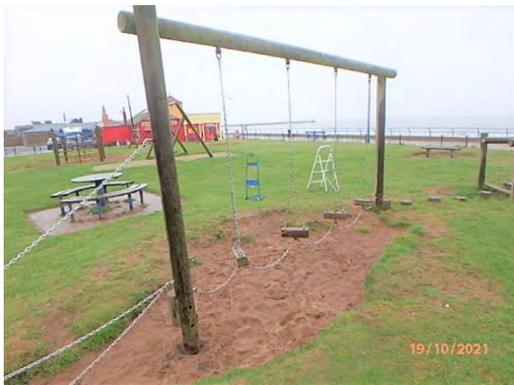
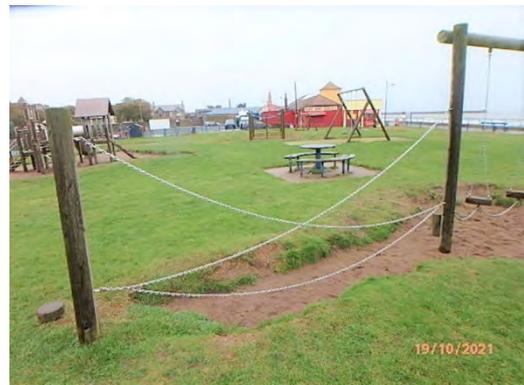
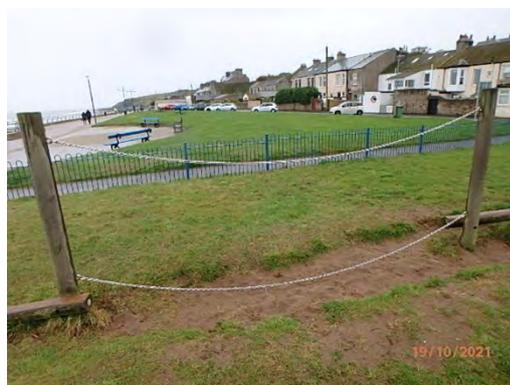
<b>Note 01/1</b>	<b>Single Post Items</b>
------------------	--------------------------

There are elements in the trail which are “one or single post items” i.e. where the stability and anchorage of the units depends on a single post or on two-legged posts or rows of posts.

It may be necessary to decommission these items before the end of their operating life especially if posts become unstable and/ or when it has not been practicable to carry out investigative checks of the condition of the timber below ground level.

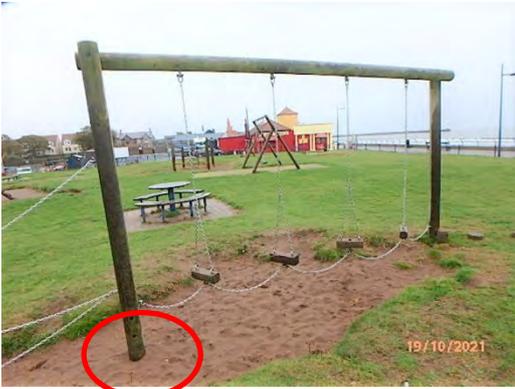
<p data-bbox="280 1599 786 1704">Single post on Swinging Steps item moves in ground when side loading applied</p>

<b>Risk Assessment</b>	High    P 3 X S 4 = 12
<b>Note</b>	This risk assessment is provisional as it is based on the external, manual checks carried out above ground level Full foundation check as per manufacturer's instructions and/or resistograph test / load test required to complete the risk assessment.

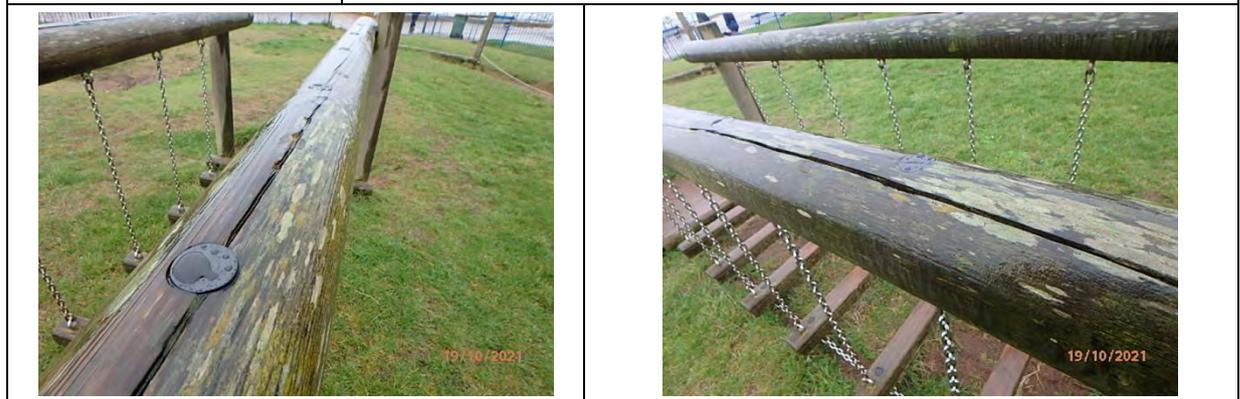
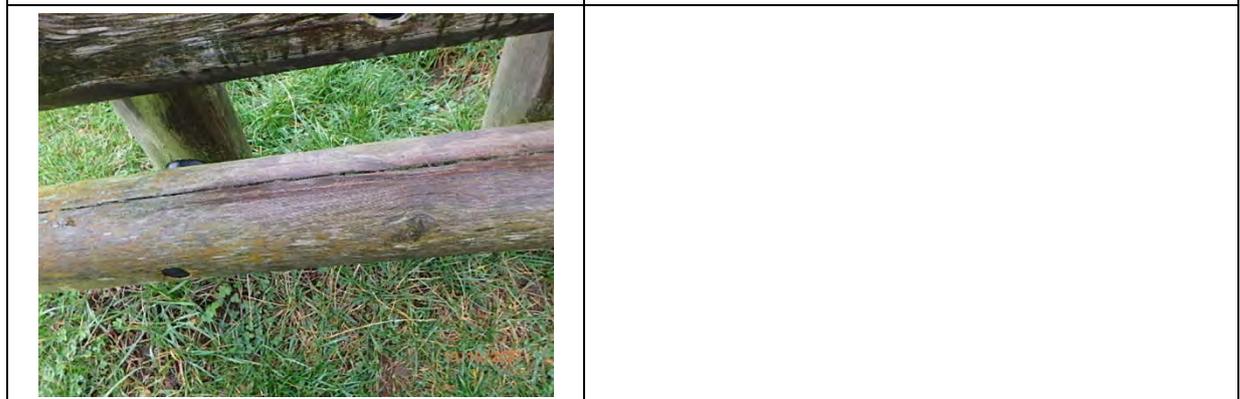
<b>Finding 01/3</b>	<b>Type</b>	Maintenance Issue
<b>Fault / Comment</b>	Cracks, splits or 'shakes' in timber noted. (Timber is affected by changes in temperature and moisture content. Cracks may expand or contract depending on climatic conditions)

<b>Hazard</b>	<p>Potential hazards arise if:</p> <ul style="list-style-type: none"> <li>• Cracks open up greater than 8 mm and become finger traps or pinch points</li> <li>• Splits appear along the whole length of the timber piece – especially if the split goes through any fixings as this could compromise the structural integrity of the affected timber and of the fixing.</li> <li>• Split is deeper than the preservative envelope and enables water ingress which may lead to onset of rot inside the timber</li> </ul>
<b>Advised Remedial Action</b>	<ul style="list-style-type: none"> <li>• Monitor size of cracks and condition of timber.</li> <li>• Check for softening of wood inside cracks as this may indicate onset of rot.</li> </ul>

<ul style="list-style-type: none"> <li>• Smooth off any sharp or splintered edges.</li> <li>• Remove or replace rotten timber</li> </ul>
<b>Risk Assessment</b>	Low P 2 X S 3 = 6

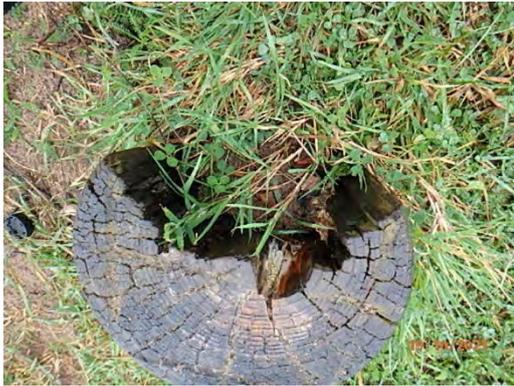
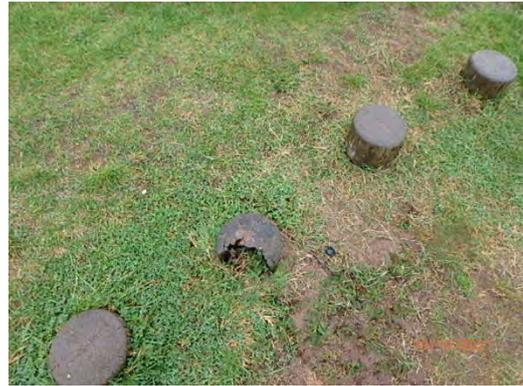
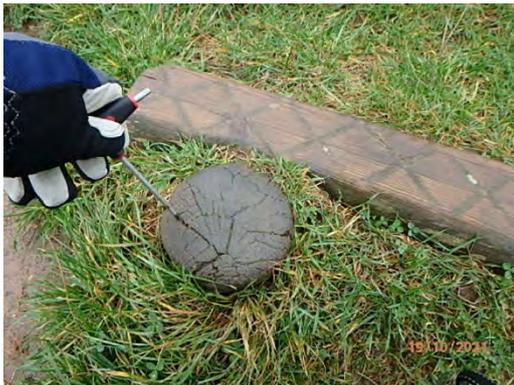
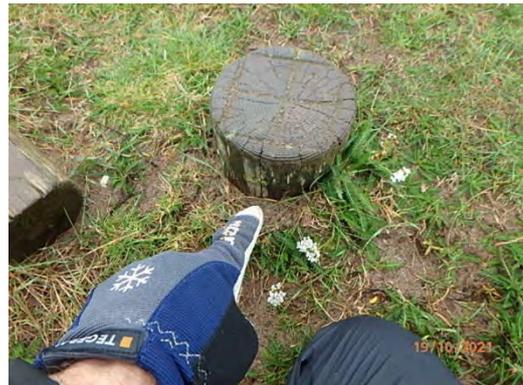
<b>Finding 01/4</b>	<b>Type</b> Maintenance Issue
<b>Fault / Comment</b>	Damage, missing parts or deterioration noted - timber parts are rotting

Short Post Steppers are rotting

<b>Risk Assessment</b>	Low P 2 X S 2 = 4
------------------------	-------------------

<b>Advised Remedial Action</b>	<p>Replace damaged posts. (Use manufacturer's recommended parts or equivalent.)</p> <p>Continue to monitor for further damage or deterioration and carry out further remedial work as required</p> <p style="text-align: center;">●</p>
--------------------------------	---

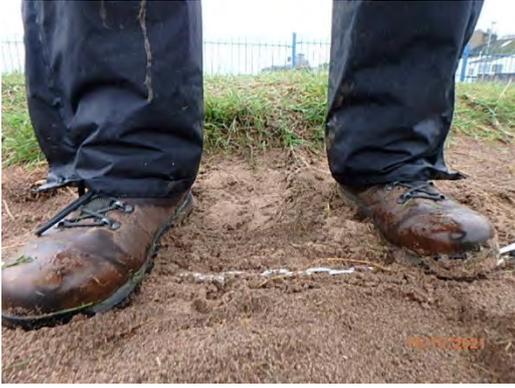
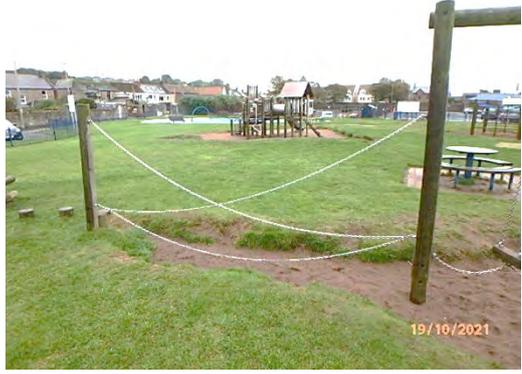
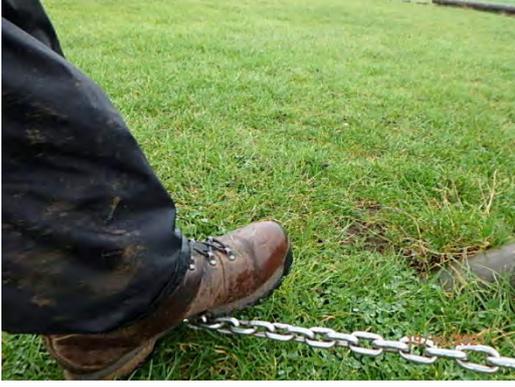
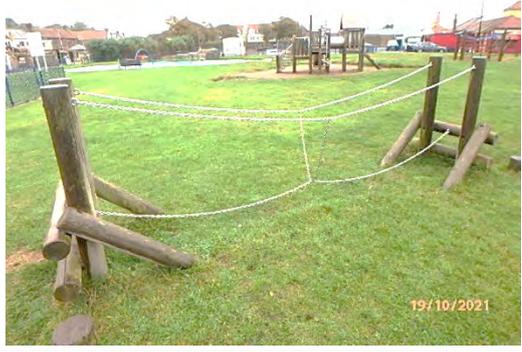
<b>Finding 01/5</b>	<b>Type</b> Maintenance Issue
<b>Fault / Comment</b>	Suspension elements touch ground when loaded –Chain Traverse and Burma Bridge.

<b>Hazard</b>	Entrapment / crush points
<b>Risk Assessment</b>	Low P 2 X S 2 = 4
<b>Advised Remedial Action</b>	Refit chains so that they are suspended – refer to manufacturer's guidelines. ●

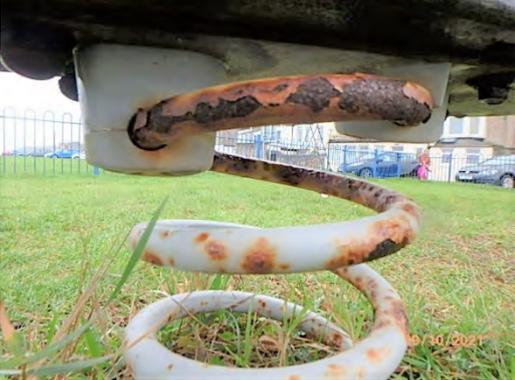
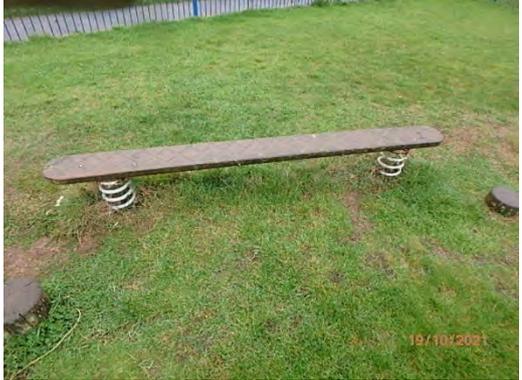
<b>Finding 01/6</b>	<b>Type</b> Maintenance
<b>Fault / Comment</b>	Parts are rusting

Spring on Wobble Board
<b>Risk Assessment</b>	Low P 2 X S 2 = 4
<b>Advised Remedial Action</b>	Programme work to clean off rust / apply anti-rust agent / repaint. ●

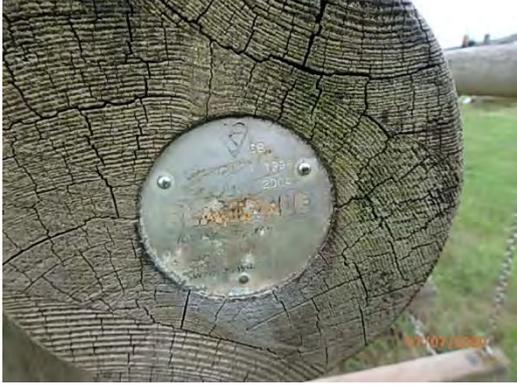
<b>Finding 01/7</b>	<b>Operating Life</b>

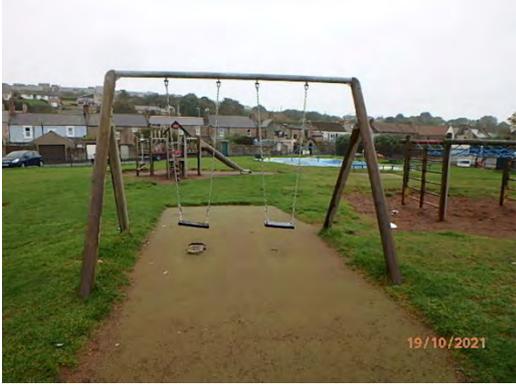
<b>Equipment 02</b>	<b>Swing – 1 bay 2 flat seats</b>

<b>Manufacturer</b>	Playdale
<b>Manufacturer's Label Present?</b>	Yes
<b>Year of Supply</b>	2014 – indicative end of operating life 2029*
<b>Accessibility (DDA)</b>	Fair
<b>Surface</b>	Carpet System
<b>Standard Compliance (EN 1176)</b>	See below
<b>Maintenance Issues / faults</b>	See below

<b>Finding 02/1</b>	<b>Type</b>	Maintenance Issue
<b>Fault / Comment</b>	Surface damage / defects

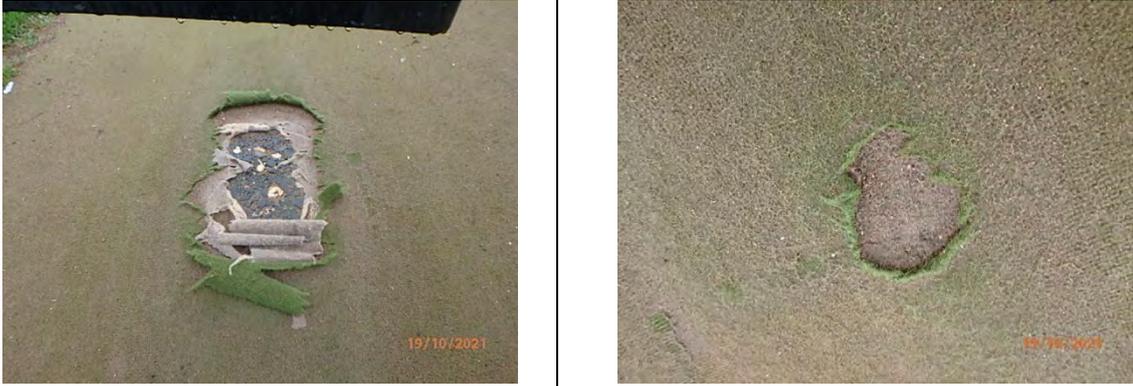
Carpet surface is torn under the seats	
<b>Hazard</b>	Impact attenuation impaired. Trip hazard. Water ingress may precipitate further damage to surface
<b>Risk Assessment</b>	Medium P 3 X S 3 = 9
<b>Advised Remedial Action</b>	Repair the Surface. ●

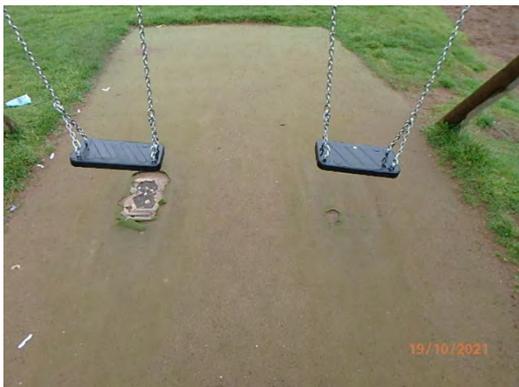
<b>Finding 02/1</b>	<b>Type</b>	Standard Compliance: EN 1176
<b>Fault / Comment</b>	The swing seats are hung too low – there is not enough ground clearance under the seats [EN1176-2:2017 ~ 4.2]

<b>Hazard</b>	Users being hit by swing seat, leg, ankle and feet injuries	
<b>Risk Assessment</b>	Low P 2 X S 3 = 9	
<b>Advised Remedial Action</b>	Adjust height of swing seats to achieve a minimum clearance of 350 mm (Recommended maximum clearance is 635 mm) ●

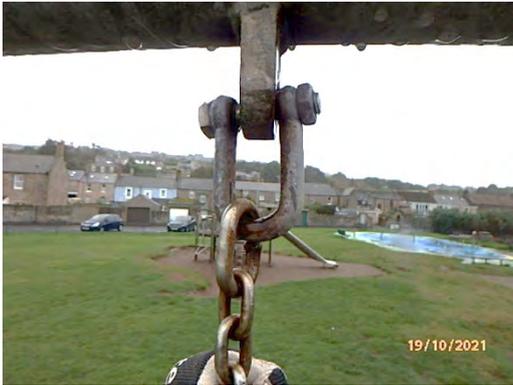
<b>Note 02/2</b>	<b>Type</b>	Maintenance – bearings
<b>Comment</b>	It is advised that swing bearings (shackles, pins, bushes etc.) are checked on a regular basis for wear and tear and damage. This requires a dismantling inspection

Note: An internal inspection of these bearings and component parts was not carried out in this inspection.

- Check swing bearings at next maintenance inspection and replace worn or damaged parts if required.
- Refer to/obtain and implement manufacturer's guidance for inspection timescales and for maintenance requirements, including the replacing of any worn or damaged elements
- Use also local knowledge of site concerning usage levels, incidence of vandalism, wear & tear etc. as an additional guide to determine frequency of dismantling checks.

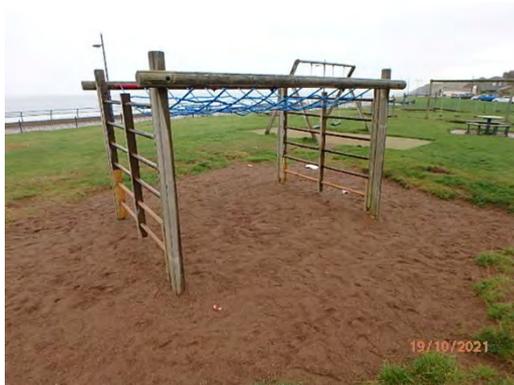
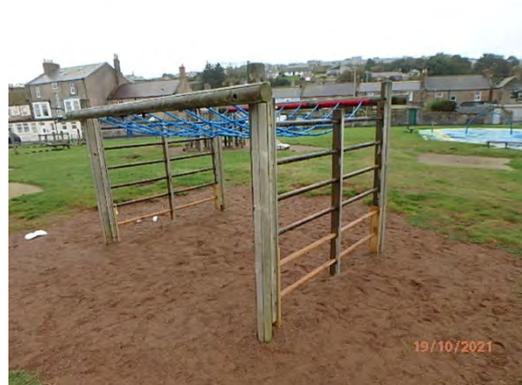
**Equipment 03**      **Climbing Frame**

<b>Manufacturer</b>	Hags
<b>Manufacturer's Label Present?</b>	None – see E02 below
<b>Year of Supply</b>	Unknown – see E01 below
<b>Accessibility (DDA)</b>	Limited
<b>Surface</b>	Sand
<b>Standard Compliance (EN 1176)</b>	See below
<b>Maintenance Issues / faults</b>	See below

<b>Finding 03/1</b>	<b>Type</b> Standard Compliance (EN 1176)
<b>Fault / Comment</b>	<p>What appears to be beach sand has been used throughout the site both as a general and safety (impact attenuating) surface.</p> <p>The sand i contains particles and small stones which fall outside the permitted range of particle sizes for LIAS surfaces given in standard. [ BS EN 1176-1:2017 4.2.8.5.2 Table 4. ]</p> <p>The inspector is unable to verify the efficacy of this sand as a safety surface.</p>

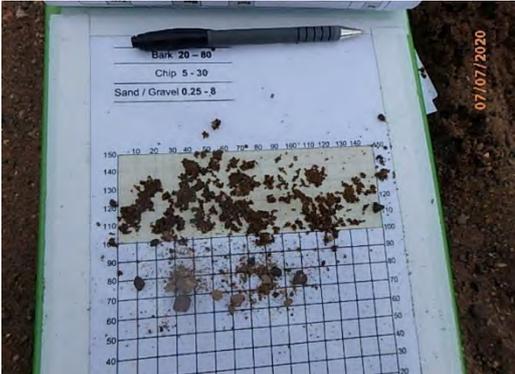
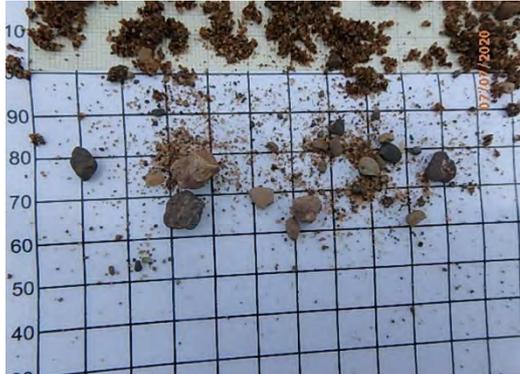
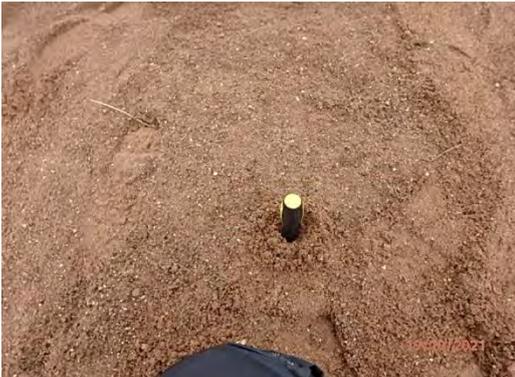
<b>Hazard</b>	Impact attenuation is untested and unverified
<b>Risk Assessment</b>	Low* P 3 X S 2 = 6
<b>Advised Remedial Action</b>	<p>Regular raking and turning over of the sand particles in the impact areas around equipment will aerate the surface and prevent compaction. This will ameliorate the risk of impaired performance.</p> <p>However, the definitive efficacy of the surface cannot be verified without further testing of the particle size of the sand.</p> <p>An on-site impact test could also be carried out on the surface, but this would provide only an indicative result of the impact attenuating qualities of the sand <u>at the time of the test</u> – as the condition of the sand would be subject to change over time due to variations in climatic conditions, moisture content etc.</p> <p>*A provisional risk assessment has been made because further testing as described above was not carried out in this inspection.</p>

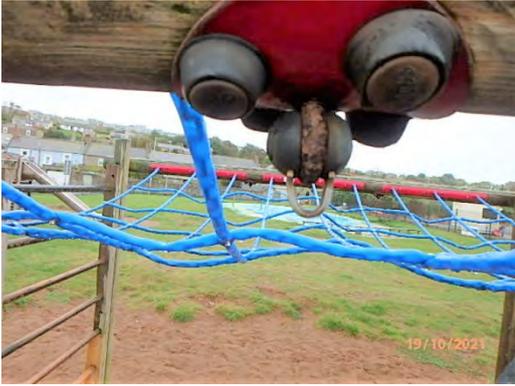
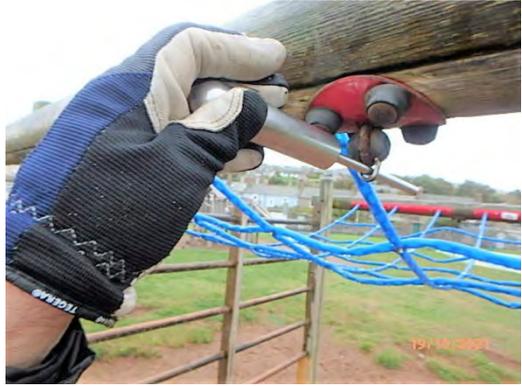
<b>Finding 03/2</b>	<b>Type</b>	Maintenance Issue
<b>Fault / Comment</b>	Damage, <b>missing parts</b> or deterioration noted.

Chains have been removed. Hanger points still in place	Eyelets are potential finger traps or snagging points	
<b>Risk Assessment</b>	Low P 2 X S 3 = 6	
<b>Advised Remedial Action</b>	Remove eyelets / hanger points ●	
<b>Equipment 04</b>	<b>Swing – 1 bay 2 cradle seats</b>

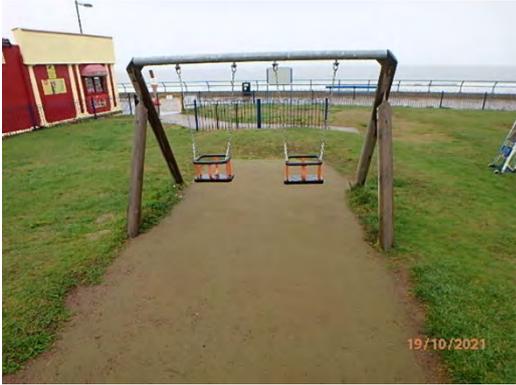
<b>Manufacturer</b>	Playdale	
<b>Manufacturer's Label Present?</b>	Yes	
<b>Year of Supply</b>	2014 – indicative end of operating life 2029*	
<b>Accessibility (DDA)</b>	Partial	
<b>Surface</b>	Carpet System	
<b>Standard Compliance (EN 1176)</b>	No non-compliance issues found	
<b>Maintenance Issues / faults</b>	Continue to maintain as normal and according to manufacturer's instructions where provided.

<b>Note 04/1</b>	<b>Type</b>	Maintenance – bearings
<b>Comment</b>	It is advised that swing bearings (shackles, pins, bushes etc.) are checked on a regular basis for wear and tear and damage. This requires a dismantling inspection

- Check swing bearings at next maintenance inspection and replace worn or damaged parts if required.
- Refer to/obtain and implement manufacturer's guidance for inspection timescales and for maintenance requirements, including the replacing of any worn or damaged elements
- Use also local knowledge of site concerning usage levels, incidence of vandalism, wear & tear etc. as an additional guide to determine frequency of dismantling checks.

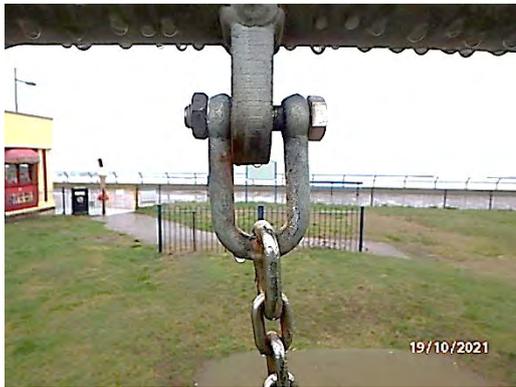
Note: An internal inspection of these bearings and component parts was not carried out in this inspection.

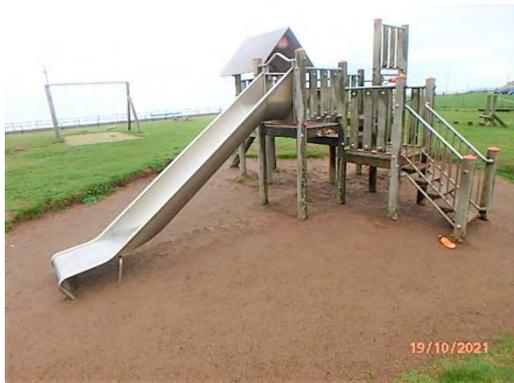
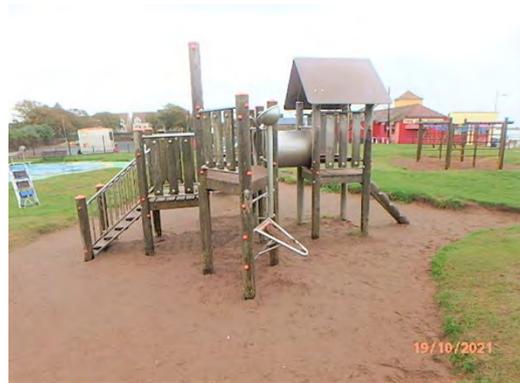
<b>Equipment 05</b>	<b>Multi Unit</b>
---------------------	-------------------

<b>Manufacturer</b>	Kaise Kühne
<b>Manufacturer's Label Present?</b>	Yes
<b>Year of Supply</b>	2004 – indicative end of operating life 2019*
<b>Accessibility (DDA)</b>	Fair
<b>Surface</b>	Carpet System
<b>Standard Compliance (EN 1176)</b>	See below
<b>Maintenance Issues / faults</b>	See below

<b>Finding 05/1</b>	<b>Type</b>	Maintenance Issue
<b>Fault / Comment</b>	Damage, missing parts or deterioration noted – Timber parts are rotting.

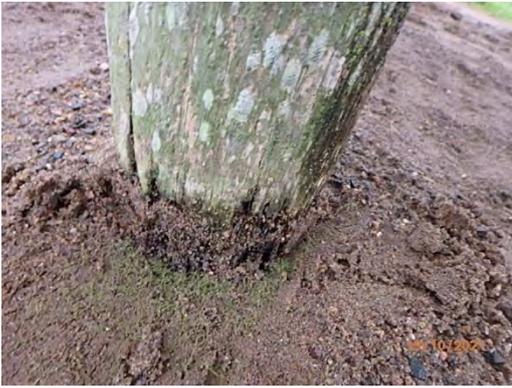
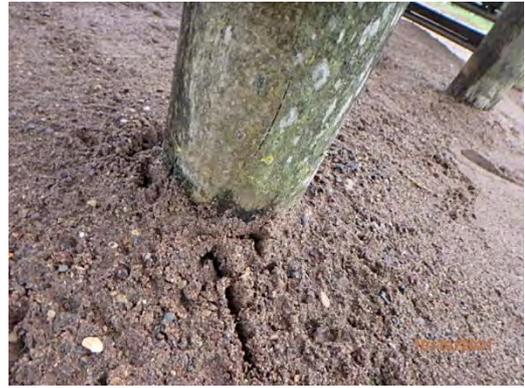
Timber posts are rotting in the ground

<p>Bottom of ladder pole is rotting</p>	
<b>Risk Assessment</b>	<p>Medium P 3 X S 3 = 9</p>
<b>Advised Remedial Action</b>	<p>Replace rotting posts. (Use manufacturer's recommended parts or equivalent.)</p>

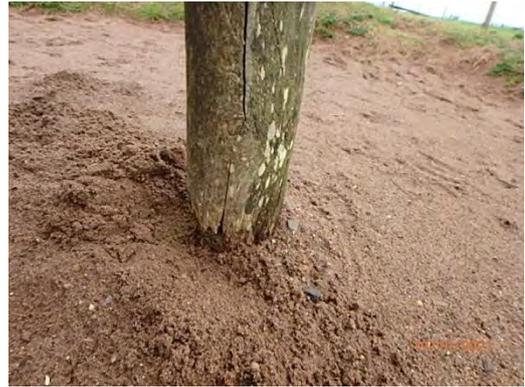
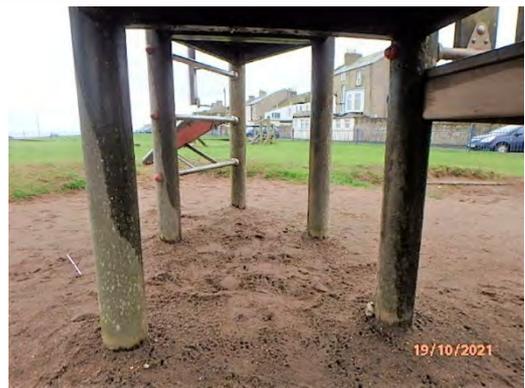
All posts under platforms

Post at bottom of steps

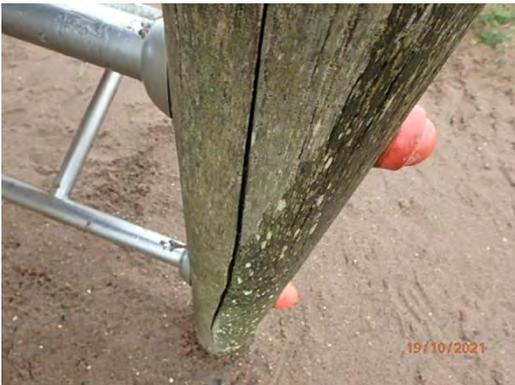
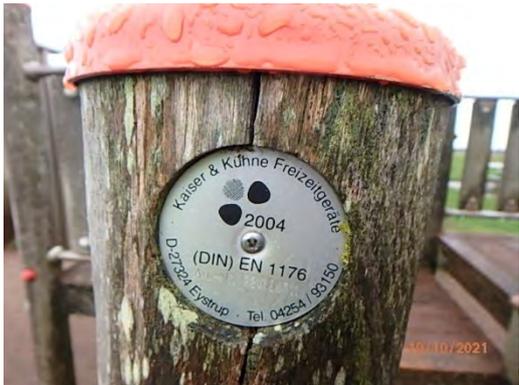
<b>Finding 06/2</b>	<b>Type</b> Maintenance Issue
<b>Fault / Comment</b>	<p>Cracks, splits or 'shakes' in timber noted. (Timber is affected by changes in temperature and moisture content. Cracks may expand or contract depending on climatic conditions)</p>

<b>Hazard</b>	<p>Potential hazards arise if:</p> <ul style="list-style-type: none"> <li>• Cracks open up greater than 8 mm and become finger traps or pinch points</li> <li>• Splits appear along the whole length of the timber piece – especially if the split goes through any fixings as this could compromise the structural integrity of the affected timber and of the fixing.</li> <li>• Split is deeper than the preservative envelope and enables water ingress which may lead to onset of rot inside the timber</li> </ul>
<b>Risk Assessment</b>	<p>Low P 2 X S 3 = 6</p>
<b>Advised Remedial Action</b>	<ul style="list-style-type: none"> <li>• Monitor size of cracks and condition of timber.</li> <li>• Check for softening of wood inside cracks as this may indicate onset of rot.</li> <li>• Smooth off any sharp or splintered edges.</li> </ul>

<ul style="list-style-type: none"> <li>Remove or replace rotten timber</li> </ul>
--	---

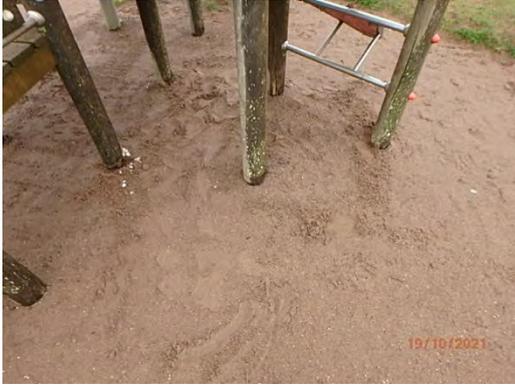
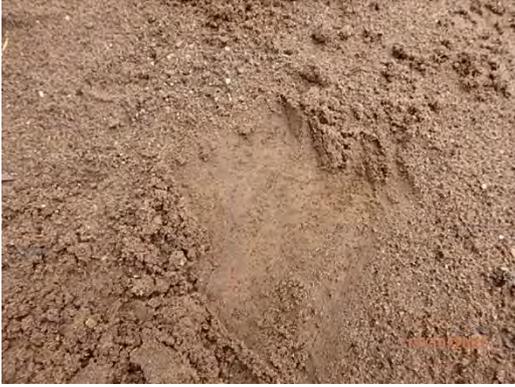
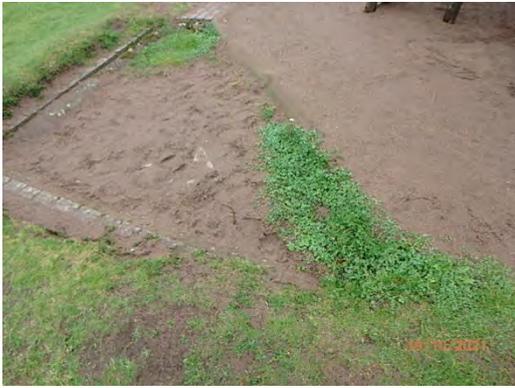
<b>Finding 06/3</b>	<b>Type</b>	Maintenance Issue
<b>Fault / Comment</b>	The carpet surface is covered over with a layer of sand

Small triangular area at one corner which should be removed / reinstated		
<b>Risk Assessment</b>	Low	P 2 X S 3 = 6
<b>Advised Remedial Action</b>	Surface should be re-instated and triangular area removed

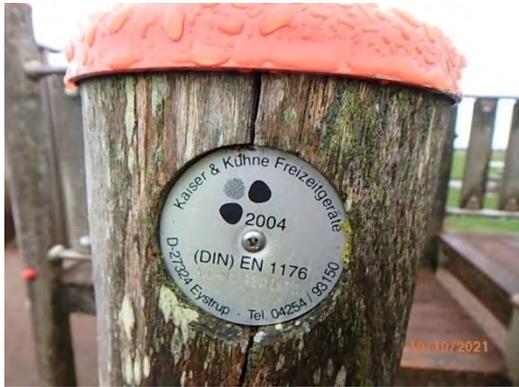
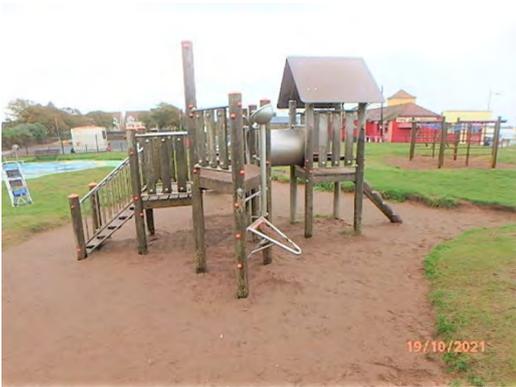
<b>Finding 06/4</b>	<b>Operating Life</b>

<ul style="list-style-type: none"> <li>Manufacturer's Label on the play equipment shows that the equipment was installed in 2004 The equipment is therefore 15 years old and planning should begin for its decommissioning / replacement.</li> </ul>

- Going forward, the equipment should be regularly checked and repairs carried out as required to ensure condition of equipment does not deteriorate until such time as the equipment can be replaced / removed.
- See E01 below
