Job Number	100182442[1]
Playground	Spittal Pavillion Playground
Date and Time of Inspection	27 January 2022 12:38:48
Inspecting Officer	
If other, please state	h
Signature

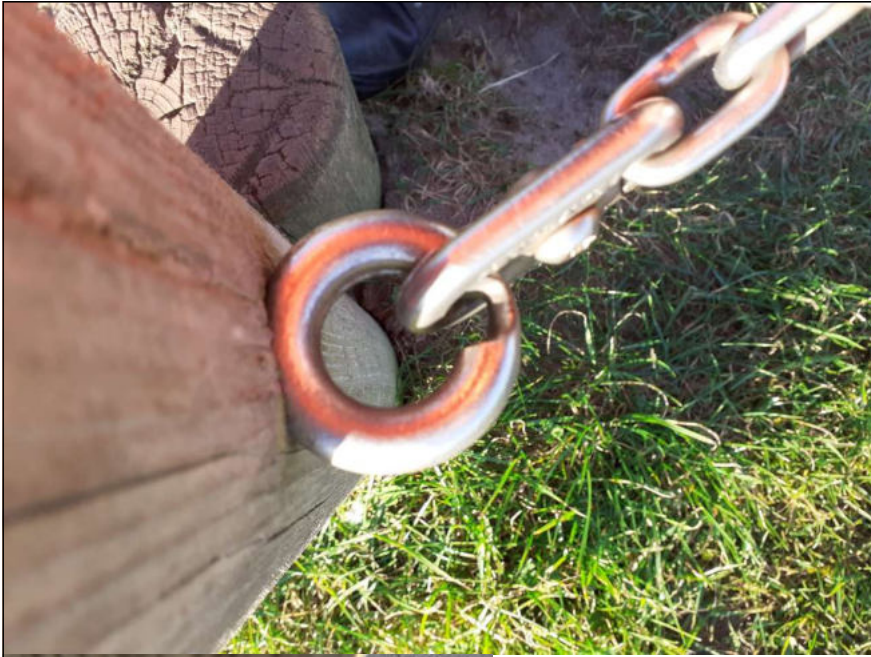
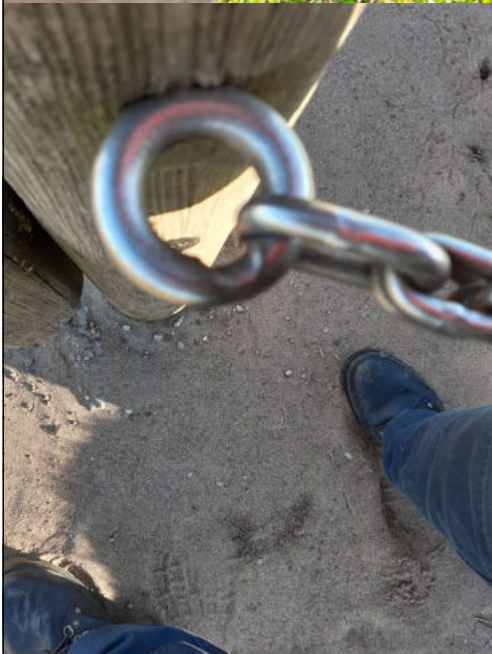
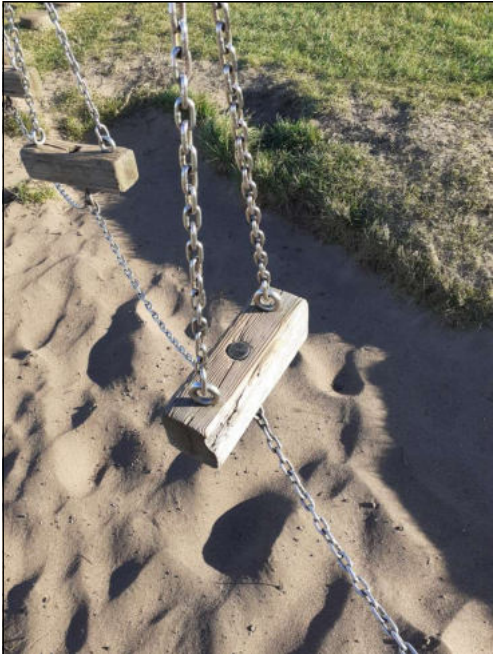
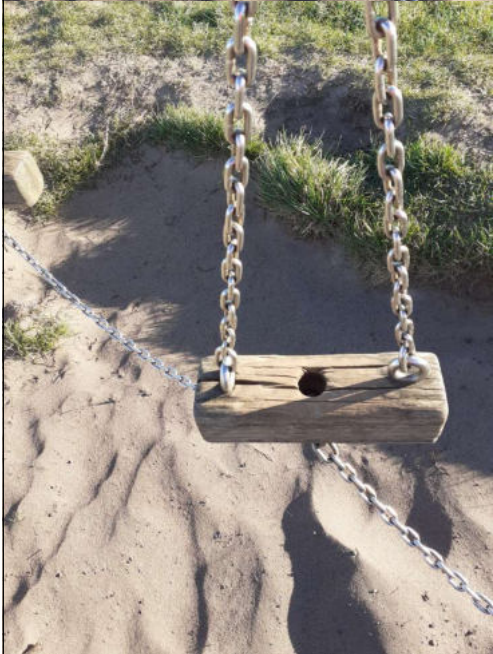
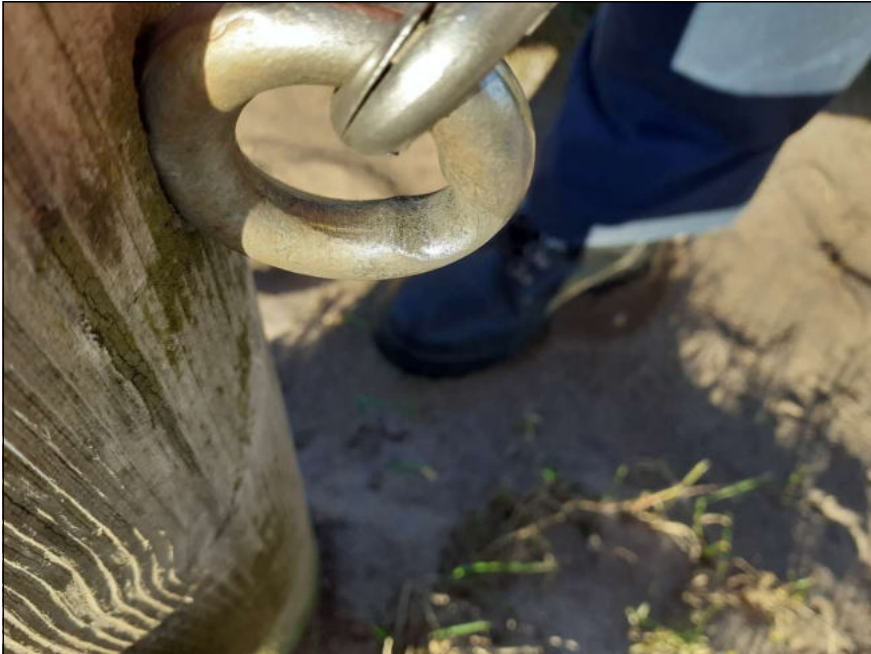
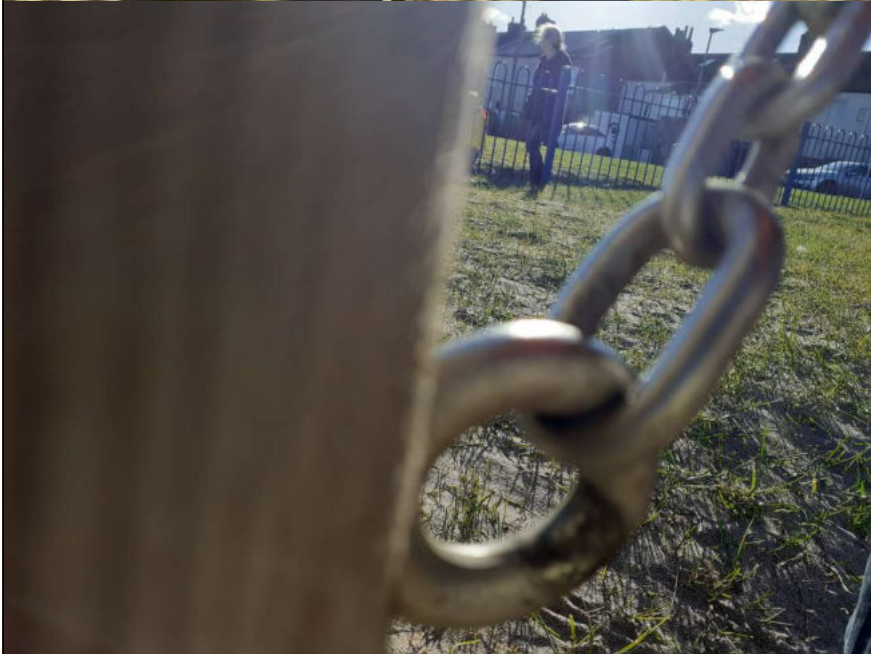
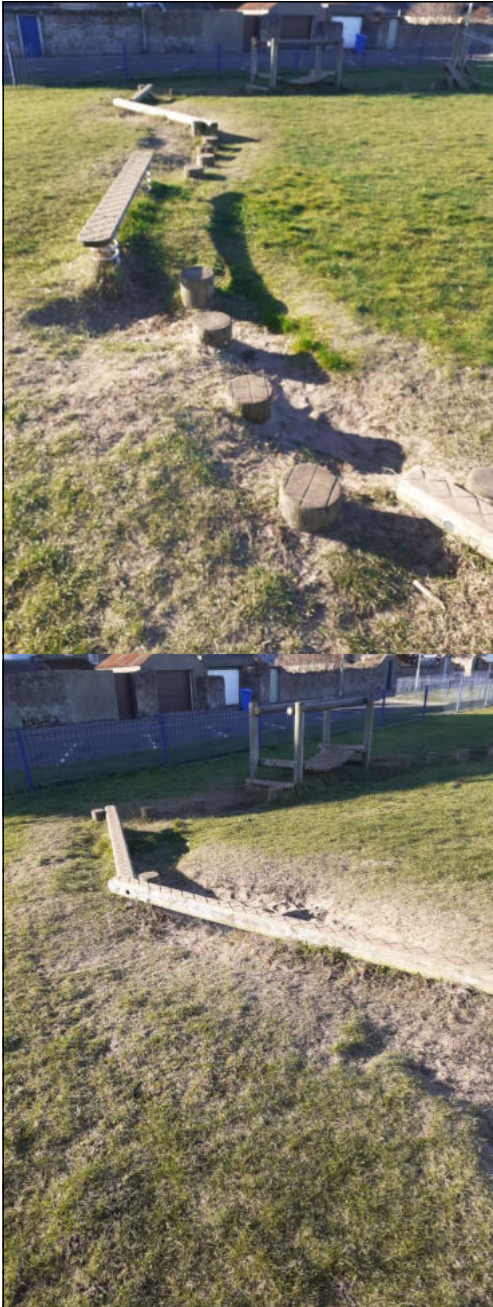
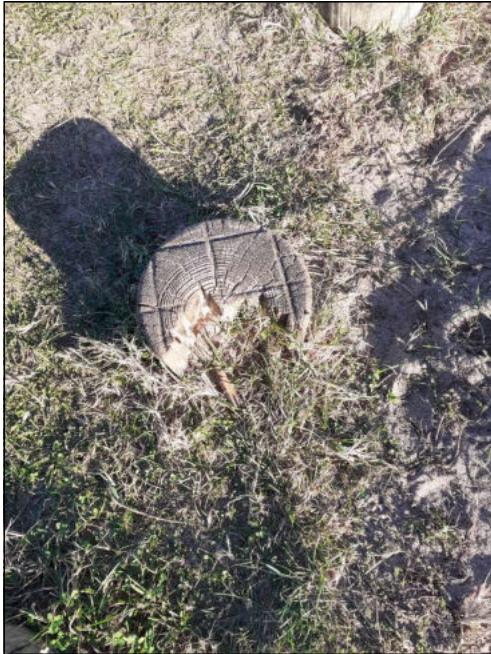
INSPECTION FINDINGS - Item unsafe, immediate action required

Question	Response
Equipment Long Description	Trim trail course (& Surface)
Equipment Reference	NCC001-PLAYEQ-PGBER016_004
Equipment Make	PLAYDALE
Equipment status	Item unsafe, immediate action required
Detail of defect	eyelets worn broken steppingstone
Risk of the defect causing injury	4 - High - An accident is likely and foreseeable without any added factor
Possible severity of injury caused by defect	4 - High - Serious injury requiring hospital admission. Long bone fractures, skull fractures, concussion etc
Date of Inspection	27/01/2022

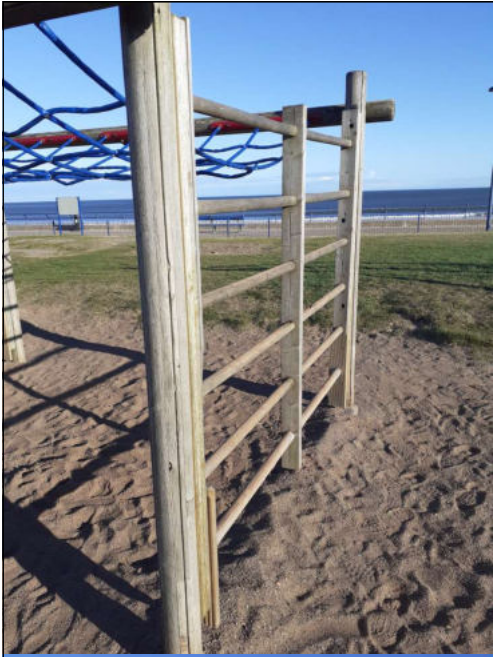
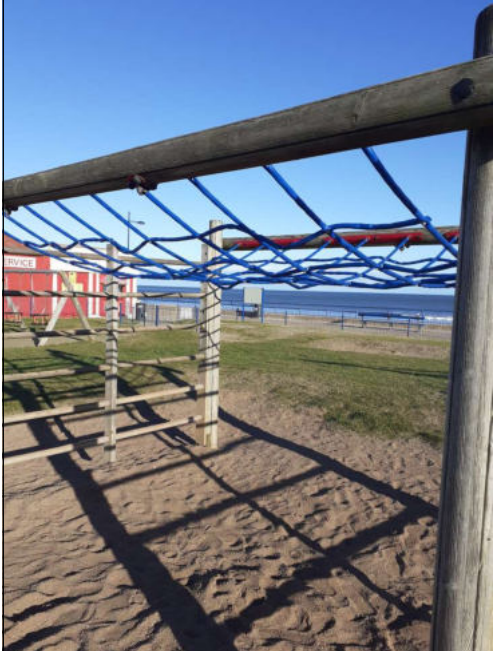
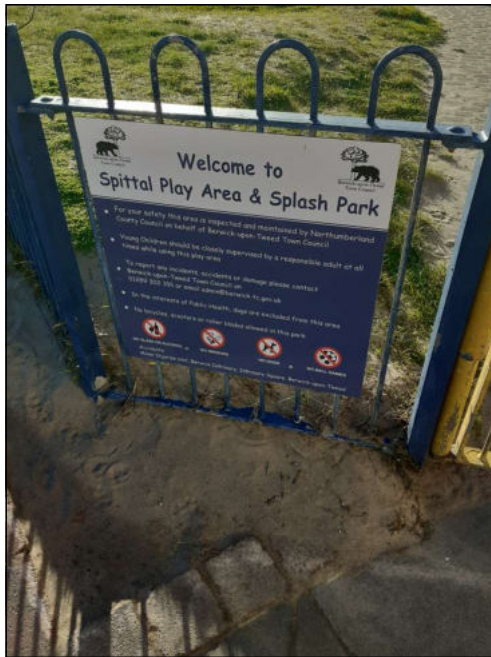
INSPECTION FINDINGS - Minor Defect, requires monitoring

Question	Response
Equipment Long Description	Wooden Multi Climbing Frame (& surface)
Equipment Reference	NCC001-PLAYEQ-PGBER016_002
Equipment Make	HAGS
Equipment status	Minor defect, requires monitoring
Detail of defect	stair rail loose
Risk of the defect causing injury	4 - High - An accident is likely and foreseeable without any added factor
Possible severity of injury caused by defect	2 - low - Minor injuries, cuts, bruises, some first aid may be necessary
Details of action taken	reported
Date of Inspection	27/01/2022

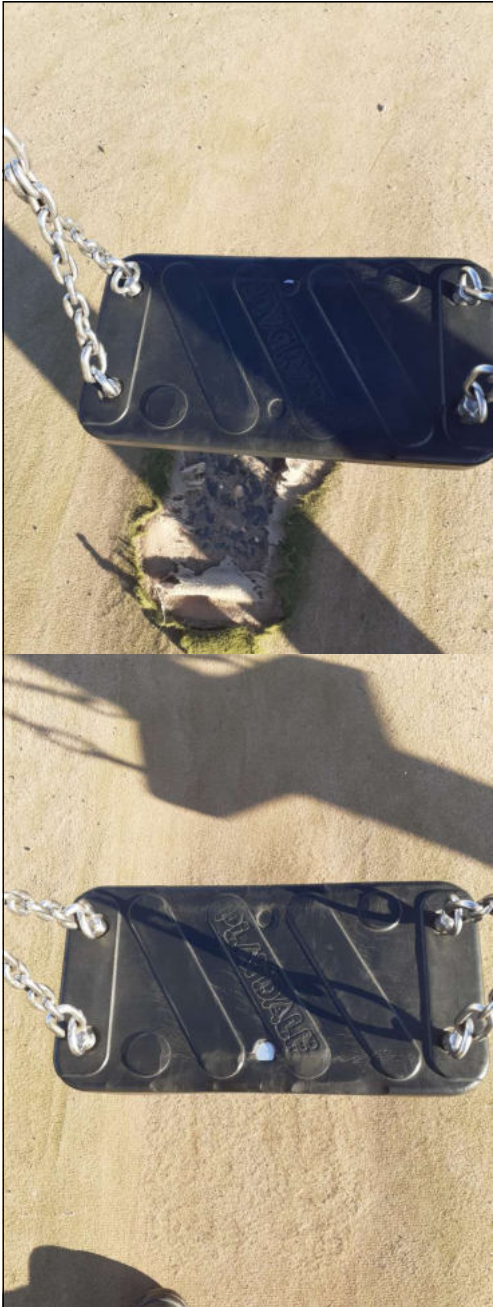
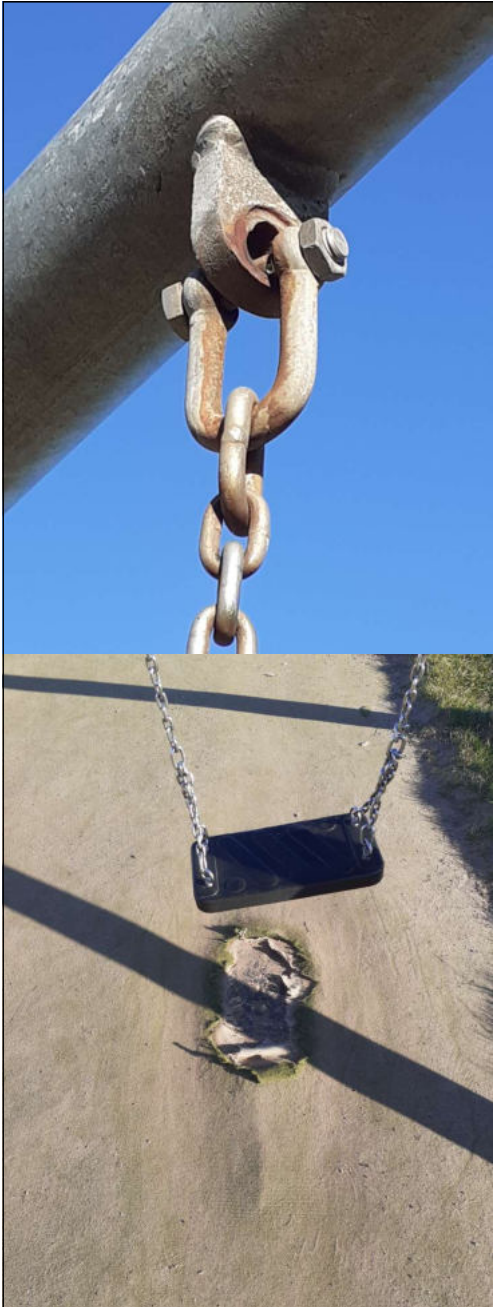
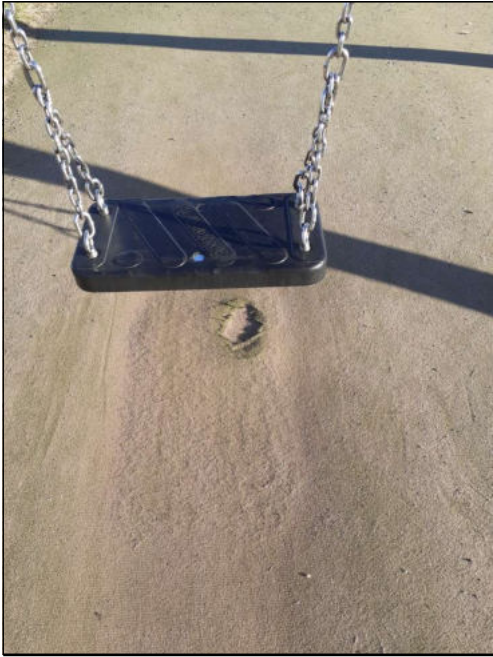
INSPECTION FINDINGS - Minor Defect, requires monitoring

Question	Response
Equipment Long Description	2 x Flat Swing set (& Surface)
Equipment Reference	NCC001-PLAYEQ-PGBER016_003
Equipment Make	PLAYDALE
Equipment status	Minor defect, requires monitoring
Detail of defect	excessive wear on top bushes, slight wear on shackles rubber seats perishing surface torn
Risk of the defect causing injury	1 - Very low - Extremely unlikely, minimal probability
Possible severity of injury caused by defect	1 - Very low - No injury likely, scratches at the most
Details of action taken	reported
Date of Inspection	27/01/2022

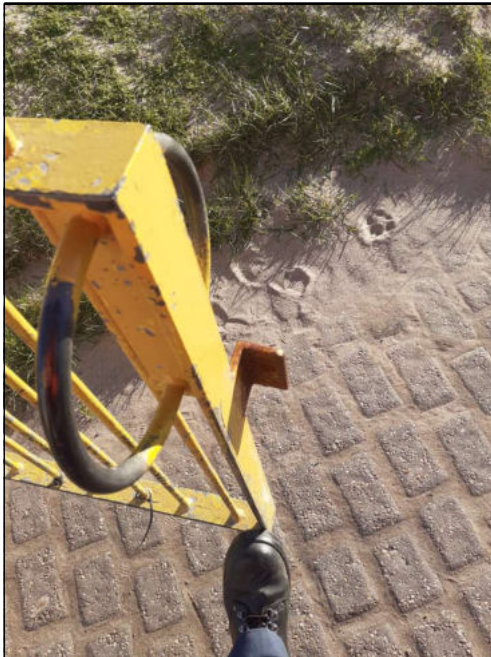
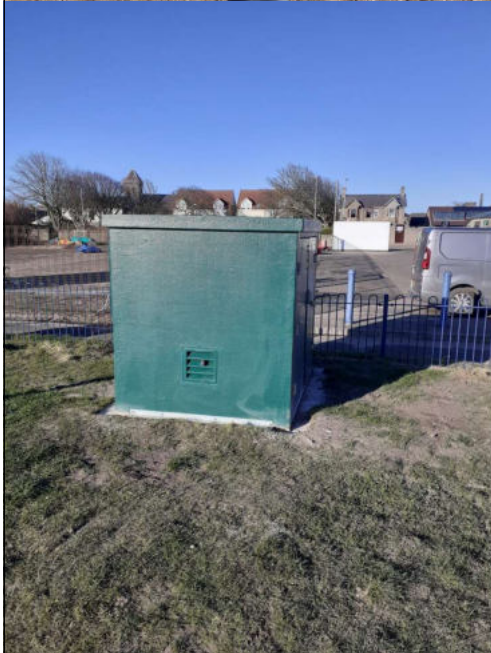
INSPECTION FINDINGS - Minor Defect, requires monitoring

Question	Response
Equipment Long Description	Perimeter fence, gates & Surface
Equipment Reference	NCC001-PLAYEQ-PGBER016_008
Equipment status	Minor defect, requires monitoring
Detail of defect	bumpstops on gates worn or missing gateloose. massive gaping hole, shelter replaced.
Risk of the defect causing injury	1 - Very low - Extremely unlikely, minimal probability
Possible severity of injury caused by defect	1 - Very low - No injury likely, scratches at the most
Date of Inspection	27/01/2022

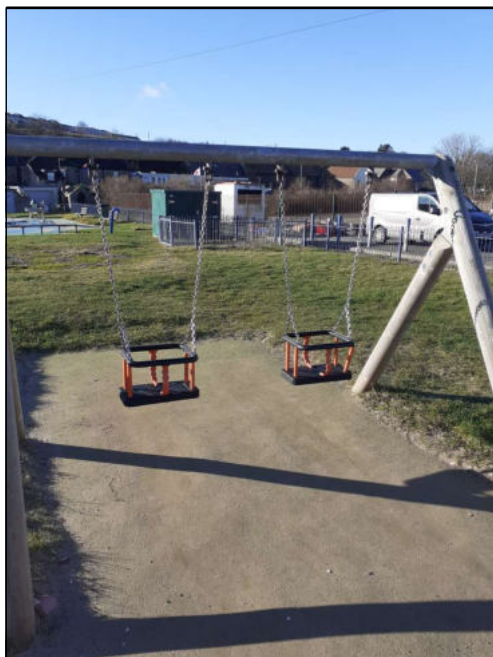
INSPECTION FINDINGS - Satisfactory

Question	Response
Equipment Long Description	2 x cradle Swings (& Surface)
Equipment Reference	NCC001-PLAYEQ-PGBER016_001
Equipment Make	PLAYDALE
Equipment status	Satisfactory
Risk of the defect causing injury	0 - No risk of injury
Possible severity of injury caused by defect	0 - No possible severity of injury
Date of Inspection	27/01/2022

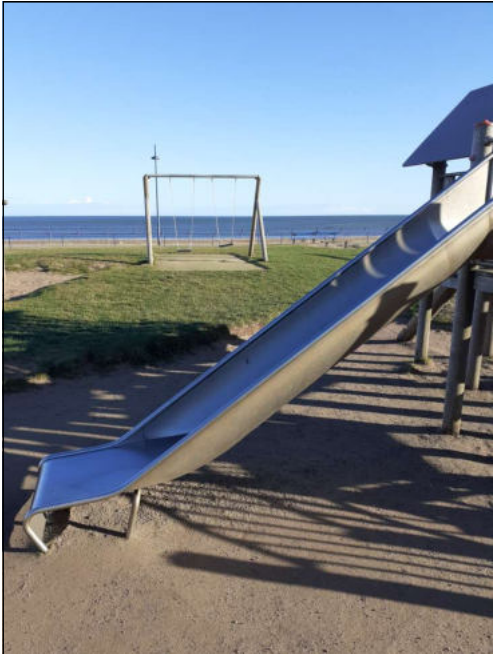
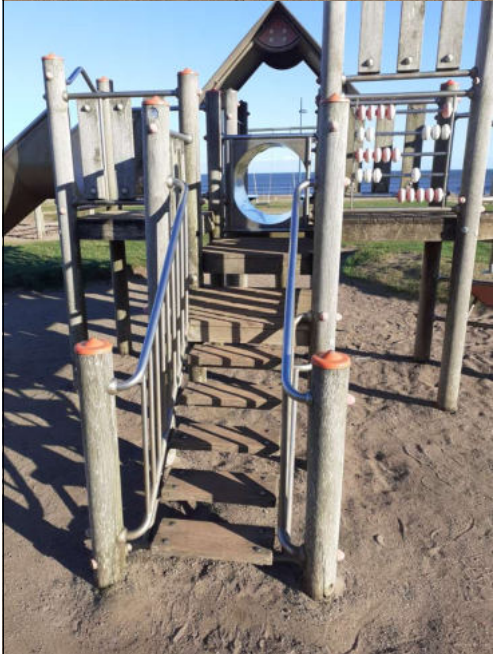
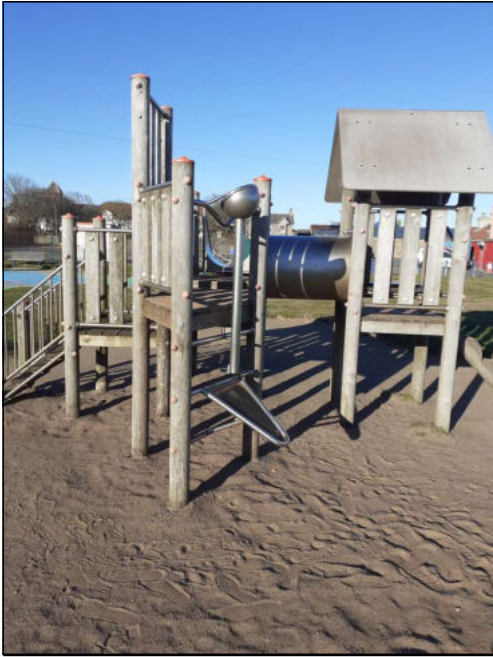
INSPECTION FINDINGS - Satisfactory

Question	Response
Equipment Long Description	Multi Unit Climbing frame (& surface)
Equipment Reference	NCC001-PLAYEQ-PGBER016_005
Equipment status	Satisfactory
Detail of defect	3 caps missing
Risk of the defect causing injury	1 - Very low - Extremely unlikely, minimal probability
Possible severity of injury caused by defect	0 - No possible severity of injury
Date of Inspection	27/01/2022
